A STUDY OF THE DPR 523 (A & B) PREPARED BY  
MICHAEL CORBETT FOR THE PROPERTY LOCATED AT  
34044 FREMONT STREET AND 33858 BEARD ROAD,  
FREMONT , ALAMEDA COUNTY, CALIFORNIA

Date: November 10, 2011

#### **Description of the Fremont-Beard Barn:**

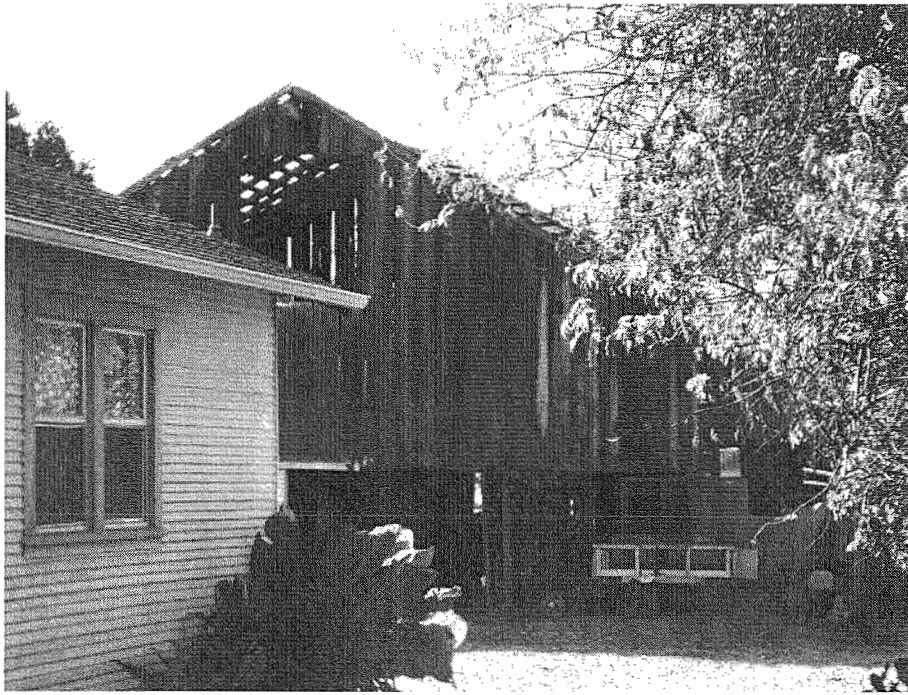
#2 Behind the house at 3565 Alvarado-Niles Road is a barn of similar style to the Fremont Beard Barn. This barn appears in context with a large working farm parcel although this may be a separate parcel as the barn is deteriorating.

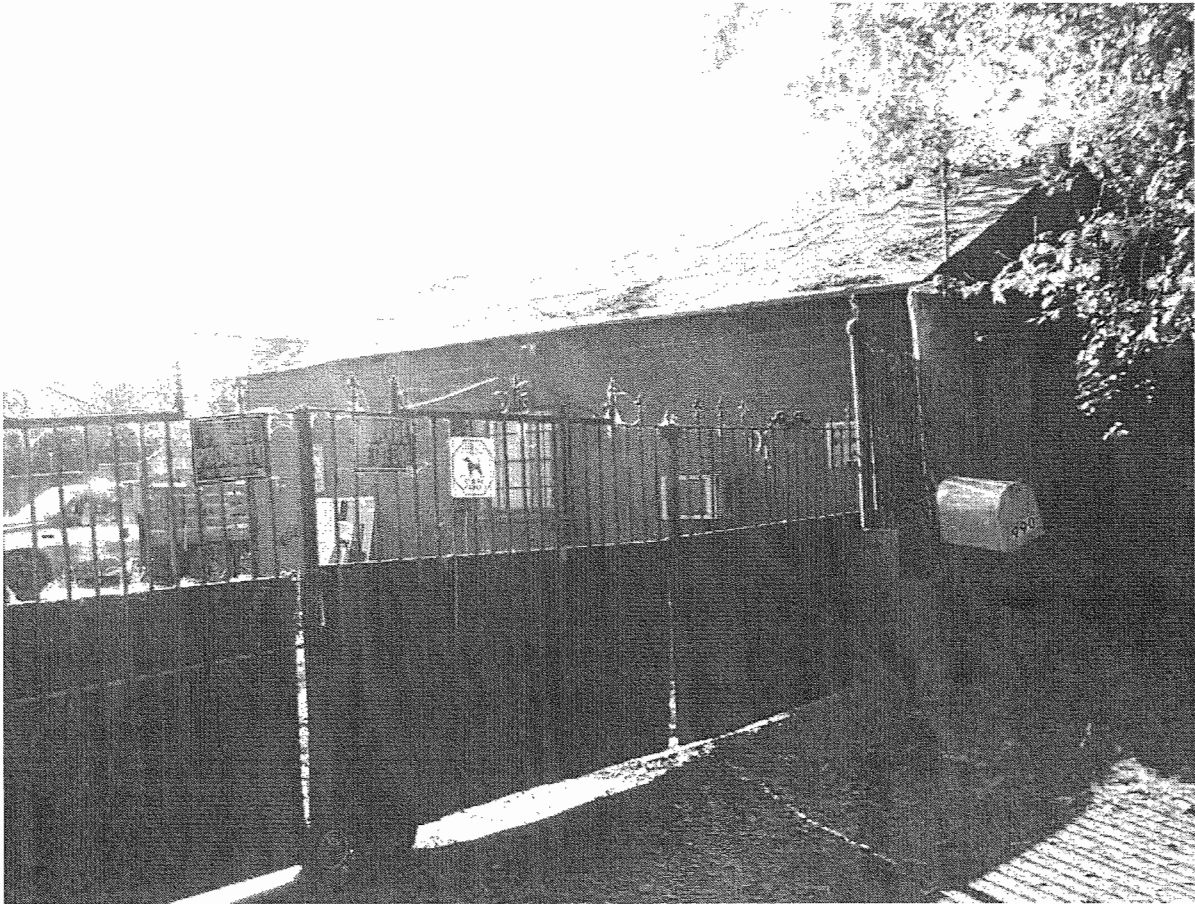
#4 A barn at 990 Kraftile Road. There are other barns and storage buildings on this property. These barns may be left from agricultural use or industrial use associated with Kraftile.

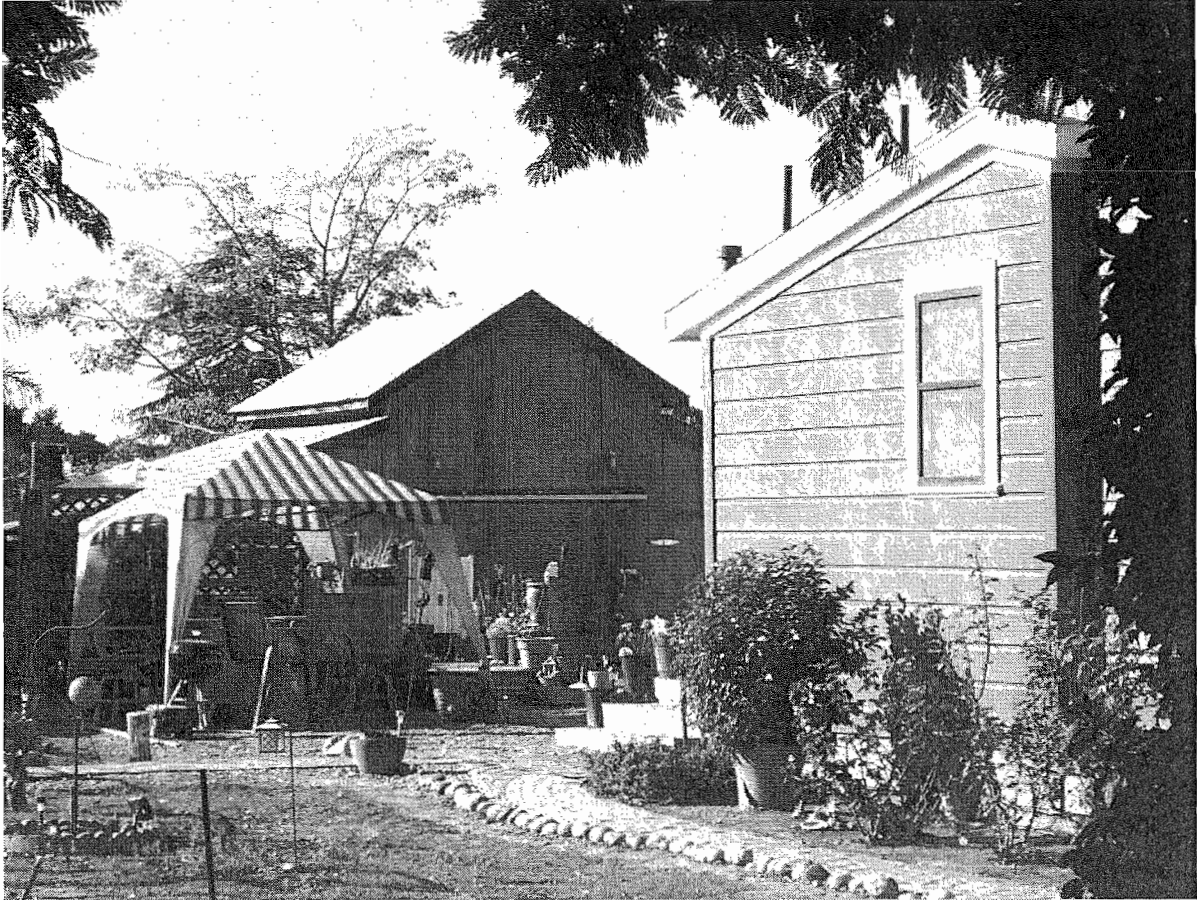
#5 This stepped roof barn clearly shows the three bays of a general storage agricultural barn. It is located at 37551 3<sup>rd</sup> street in the Niles District.

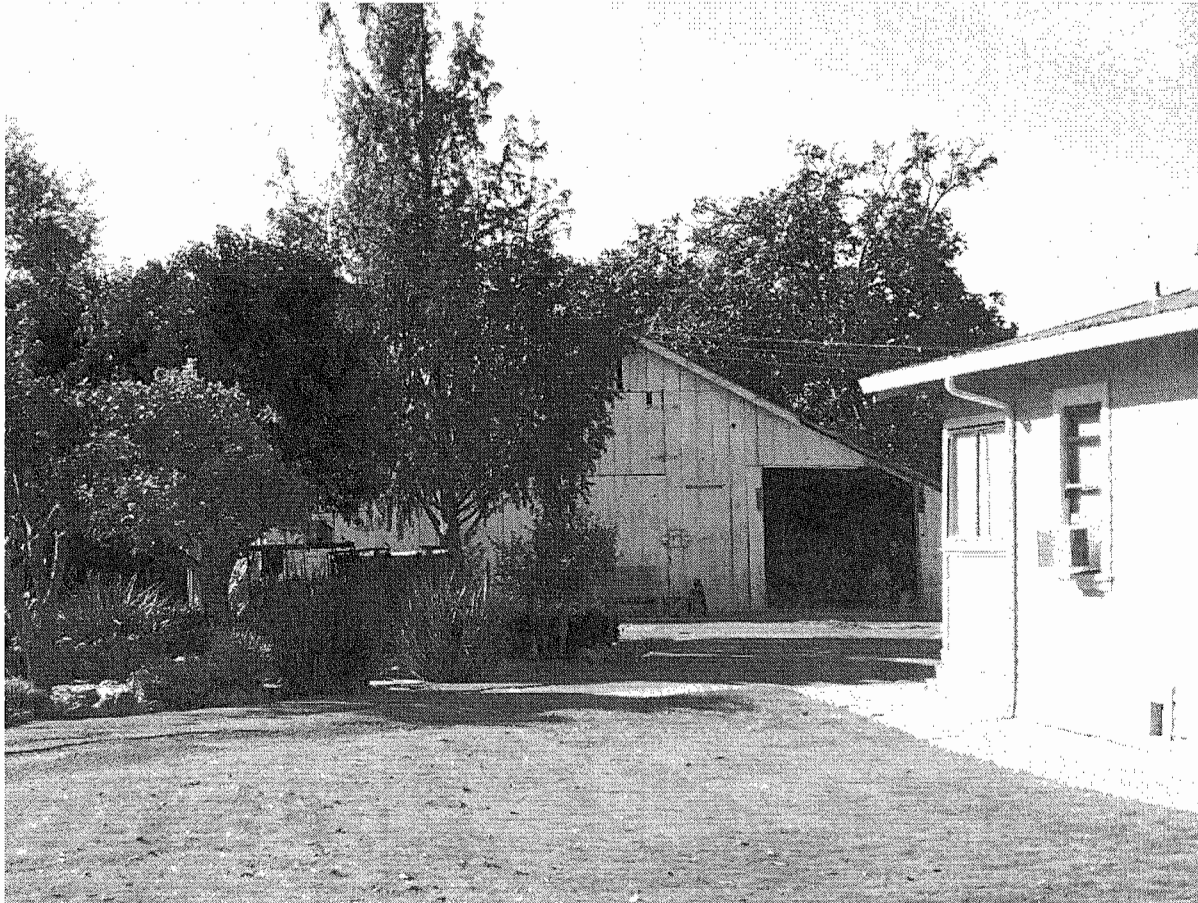
#6 This barn is very similar to the one on the Beard-Fremont Property. It is located at 12793 3<sup>rd</sup> Street in the Niles District. In the last two photographs it is shown how close the house is to the barn. This was likely the case at the Beard-Fremont parcel where palm trees – generally associated with a house-remain.

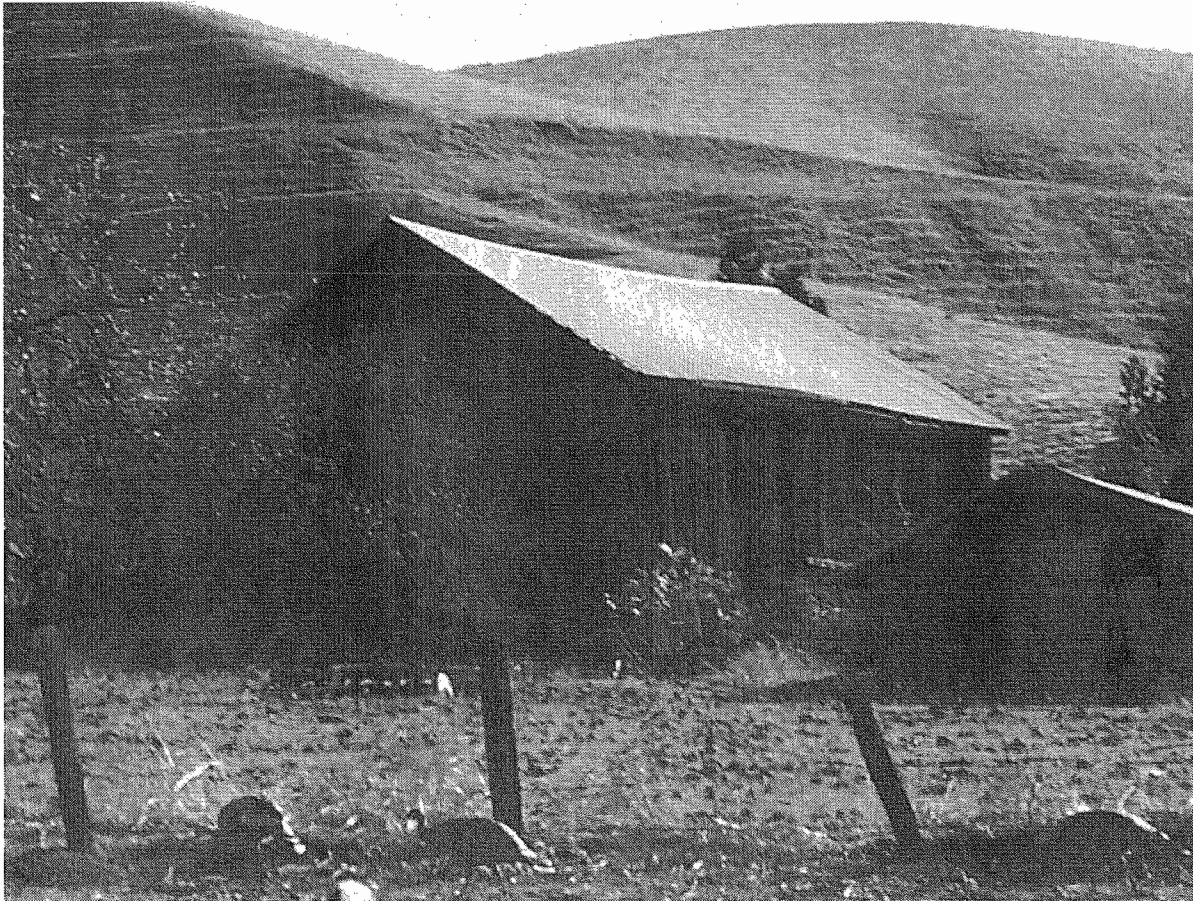
#7 A rural barn that appears to be in use, located off Mission Blvd. There are a couple more working barns off Mission Blvd in the area west of Interstate 680. They are difficult to photograph from the public street.
